A NEW PERSPECTIVE ON COURTYARD HOUSE STRUCTURES

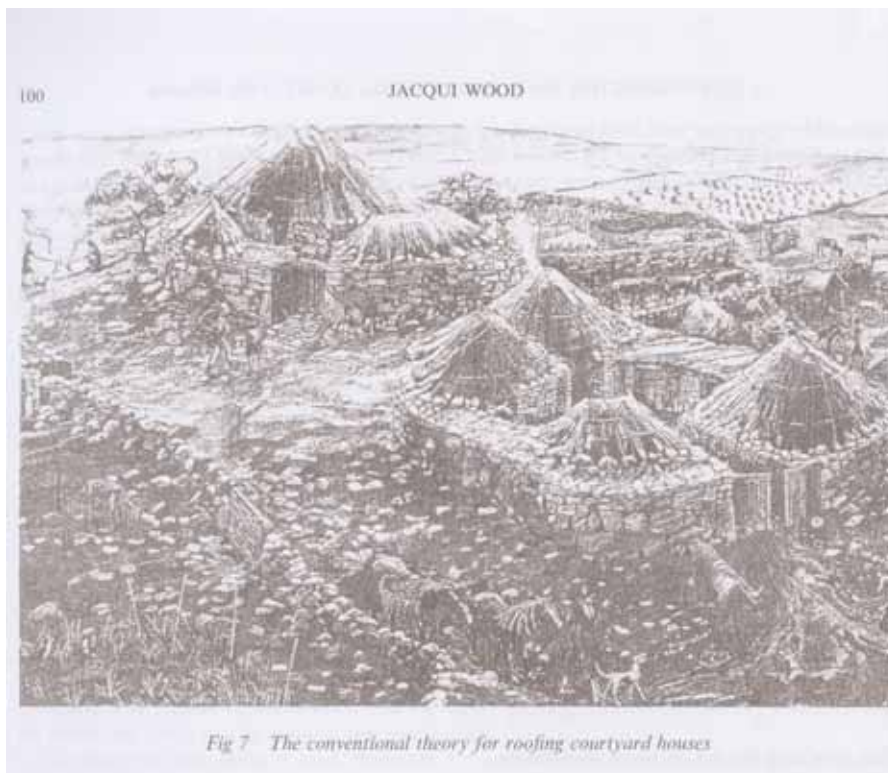
There are two possible methods for roofing these dwellings. The conventional theory of roof construction, with a central open courtyard (Fig 5). Looking a Hut 6at Chysauster for this comparison, beginning with Room 6d. Due to its oblong shape it would require a hipped roof 6d. After constructing the hipped roof on room 6d the ends of the roof, must be set on to the centre of the Courtyard house walls. This is represented in the English Heritage interpretation boards at the site.

into the infill in the walls between room 6e and room 6d, and also between room 6d and room 6b. (see Fig. 5). Next the partitioned room, 6b, viewed as one room, has to be roofed. Another hipped roof would be appropriate here, with two supporting forked posts, as this is it would not merit three supporting posts, with a cross member placed between the two forks. The usual artists impression of this type of room in a courtyard house has an almost flat lean-to roof over these side rooms. In my opinion, this would not be weatherproof, as the pitch would not allow the thatch to drain. The oval ends of 6b/6c buttress up to the bottom of the thatch of room 6d and will do the same between 6b/6c and room 6a. Room 6a is a near perfect round, so a typical conical roof indicative of normal roundhouses, with the steeper pitch would be required. As the walls are so thick at the courtyard entrance side of this room, it would be very difficult to have all but a small overhang of the thatch of room 6a. The area between 6f and 6e is normally also shown on artists interpretations as a long flat roof. Which, as noted above, this would not withstand the rainfall characteristic of the area.

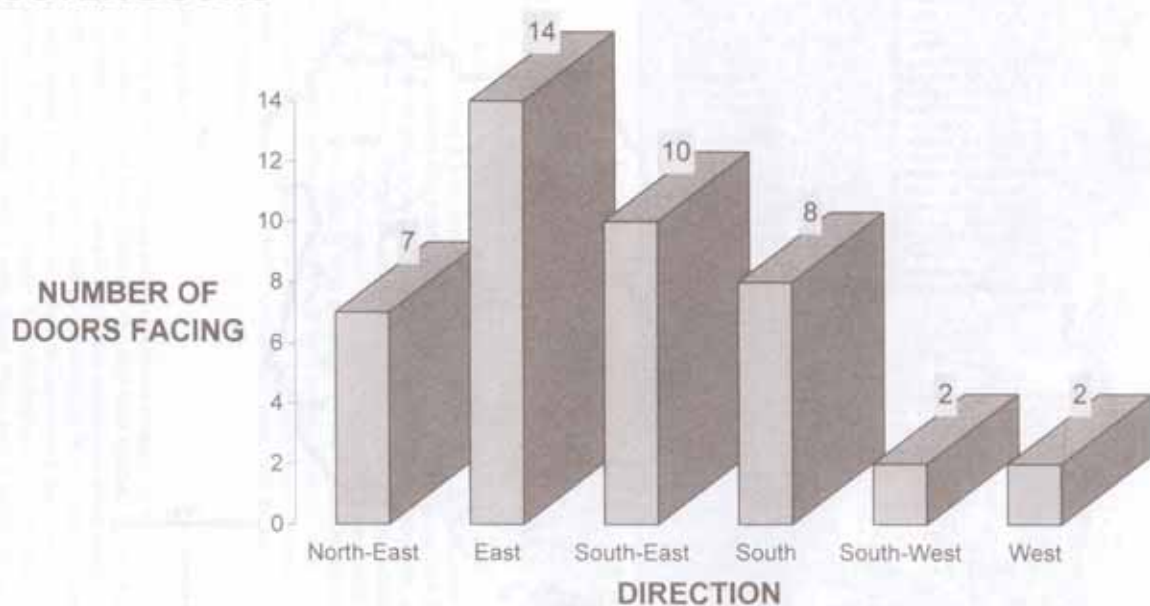
Fig 9 The orientation of courtyard houses' outer doors

Courtyard houses are generally situated along ridges on moorland, on the north coast of West Penwith. The topography is bleak, with the prevailing wind from the west, the first land reached by the Atlantic Gales. Therefore, the direction of the wind would have been considered when building a dwelling. All the known courtyard house sites in West Penwith were examined with a view to establishing in which the direction of the main courtyard doors were set. Of 53 known courtyard house sites, 11 faced directly South, 14 South East, 14 East and 6 North East. Altogether 45 were sites faced away from the prevailing wind. Only 2 sites faced West, 3 South West and 3 North West (Fig 6). The 3 North West sites had some form of shelter from the wind, either a house directly in front of them or in a sheltered valley. This is compelling evidence, that the orientation of the courtyard doors took into account prevailing winds.

The survey, of the orientation of the outer courtyard house doors indicates an awareness of the importance of the prevailing westerly winds. The preponderance of south, south east and easterly outer courtyard doorways, seems to indicate this. The raised floor of Hut 6a, with its doorway facing directly into the prevailing westerly winds, and the ensuing problems this would incur to the inhabitants of this dwelling is an anomaly. This leads to the supposition that the entire structure was roofed, and that the courtyard was actually a central hall. There may possibly have been another floor structure on top of the room walls, supported by the large infilled areas, between the separate rooms. As indicated in (Fig 9). This suggests that the courtyard house was a substantial dwelling, capable of housing large, extended families. With its substantial central hall, (possibly re-named galleried houses) the upper gallery floor would be an impressive sight on entering the central hall. This area would have been warm and dry benefiting from the rising hot air of the pit fires on the ground floor. The rooms below could have been stores or workshops which would be a considerable advantage during winter. This paper perhaps throws new light on these structures, that are such a predominant feature in the West Cornwall landscape.
